UTILITY VEGETATION MANAGEMENT FINAL REPORT

MARCH 2004

**FEDERAL ENERGY REGULATORY COMMISSION
UNITED STATES GOVERNMENT**

**COMMISSIONED TO SUPPORT THE FEDERAL INVESTIGATION
OF THE AUGUST 14, 2003 NORTHEAST BLACKOUT**

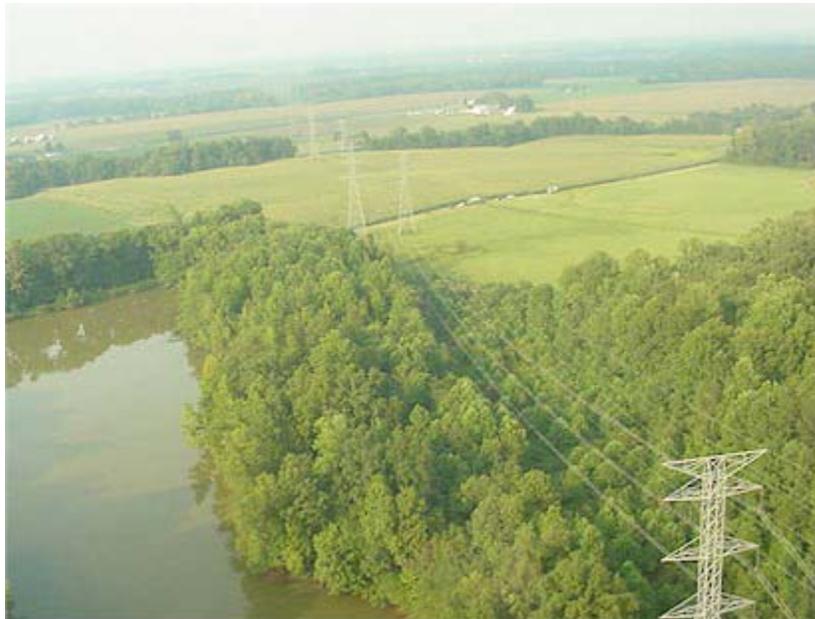
The issue, and exposure, of individual refusals is best illustrated by reviewing the outage that occurred on August 14th on Cinergy’s Columbus – Bedford 345kV line (see Appendix ‘D’ for a detailed description of the incident). Had this refusal been on one of the lines that contributed to the blackout, it could have been accurately stated that an individual landowner was, from one perspective, largely responsible for triggering one of the worst outages in North American history.

Work on this span on the Columbus – Bedford 345kV line had been halted various times by the owner of the property. The owner of the property had severely limited the ability to achieve necessary clearances and to apply herbicides to control future growth. This landowner has successfully halted work from proceeding on several occasions. This included the homeowner obtaining a court-granted temporary injunction against the utility.

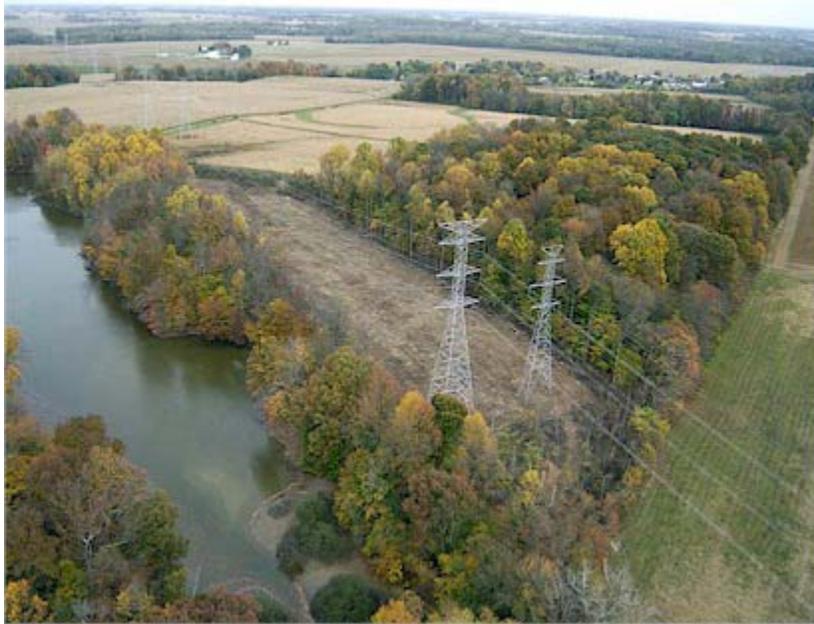
The required work was finally completed on October 9, 2003 as depicted in the photo below.

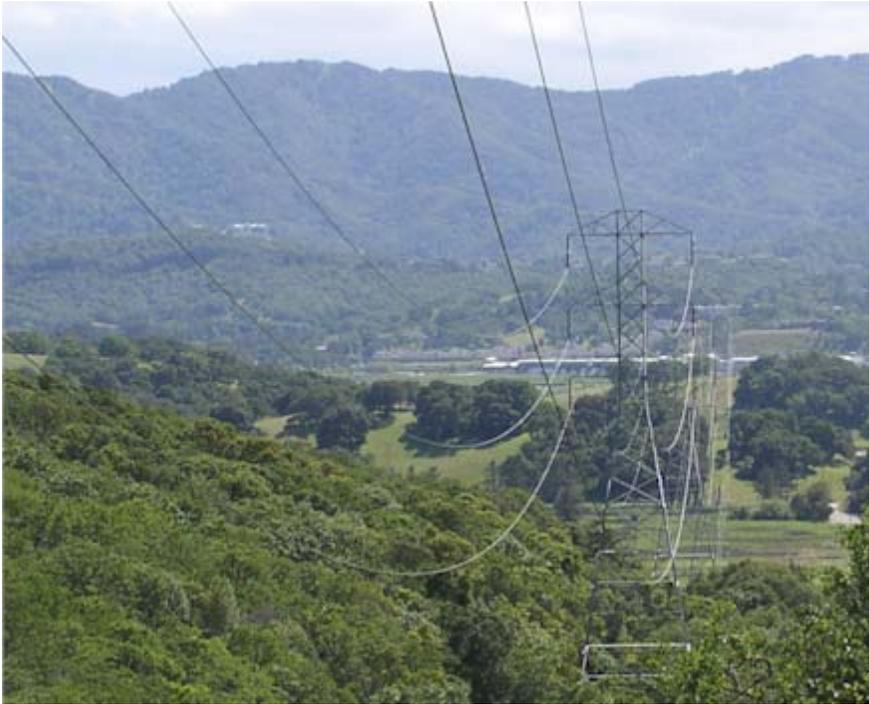
Transmission Line

The following photos depict typical transmission and distribution facilities.

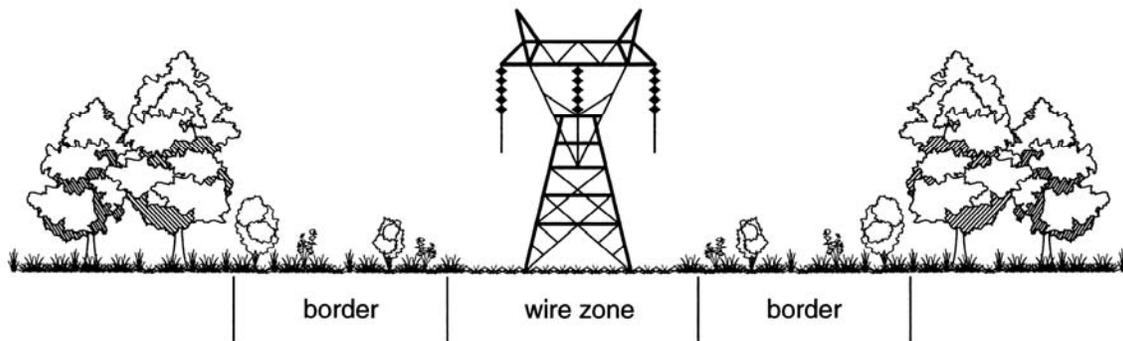
Bramble and Byrnes Wire Zone – Border Zone (From Yahner, Bramble and Byrnes, 2000)

There is industry consensus as to how a transmission ROW should be established and maintained. From an electric reliability standpoint, it simply requires managing vegetation so that it cannot grow into, or fall onto the energized facilities. It requires creating a predictable and low-growing environment of vegetation under and adjacent to the ROW. The following graphic illustrates this simple concept.

As the graphic describes, this concept is typically referred to as the Wire Zone - Border Zone model, and it has, based on years of research¹³, been proven to be effective in reducing and/or eliminating outages related to vegetation on transmission ROWs. In addition, this research has proven that the Wire Zone - Border Zone model generates a great many more benefits than just reducing outages. These benefits include reduced long-term maintenance costs, improved habitat for wildlife, biodiversity, and wildland fire mitigation.

While we recommend that this model be used wherever possible, there are locations where this may not be practical. There are locations where transmission lines are not located on clearly defined and documented ROWs. These lines may also be located in more urban areas where the Wire Zone - Border Zone model may not be appropriate due to existing landscaping or property lines. With that said, we do believe that this model should be utilized whenever new lines are built, and wherever existing lines will allow. This model could and should be applied to the vast majority of transmission lines.

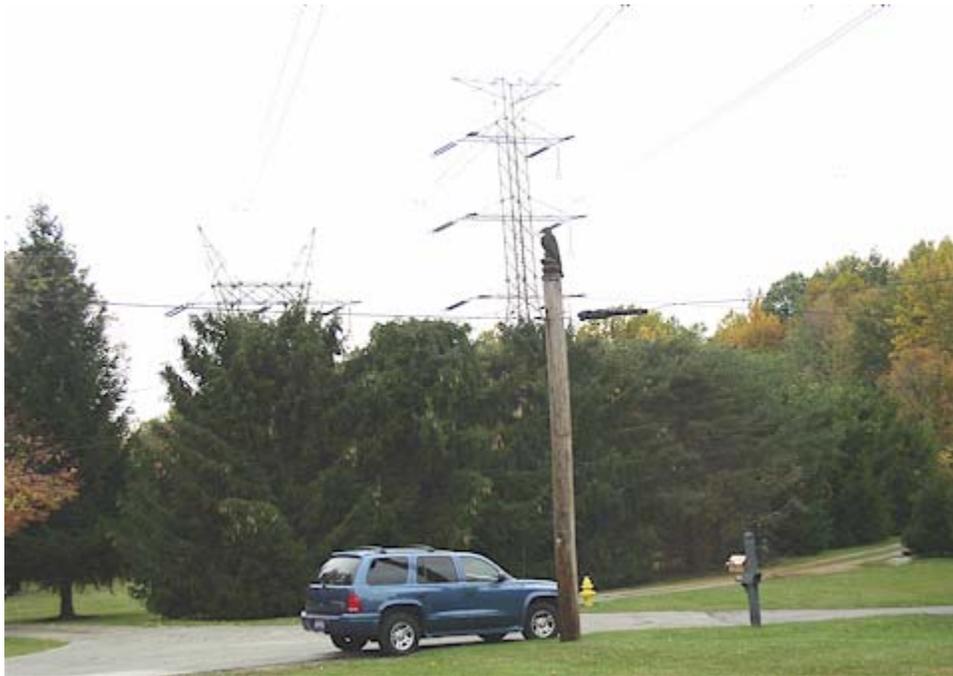
Fortunately, many utility companies have recognized this problem and are taking active measures to “reclaim” these ROWs. Unfortunately, reclaiming ROWs is often a difficult and costly process. One example of these difficulties arises when a landowner plants landscaping within the ROW and the utility allows it to exist over an extended period of time. This problem is illustrated in the following picture taken a few spans away from the fault location that occurred on the Hanna – Juniper 345kV line.

Above, the landowner has planted a row of trees directly underneath the transmission lines. If the utility chooses to enforce the documented easement rights, it would be able to remove this

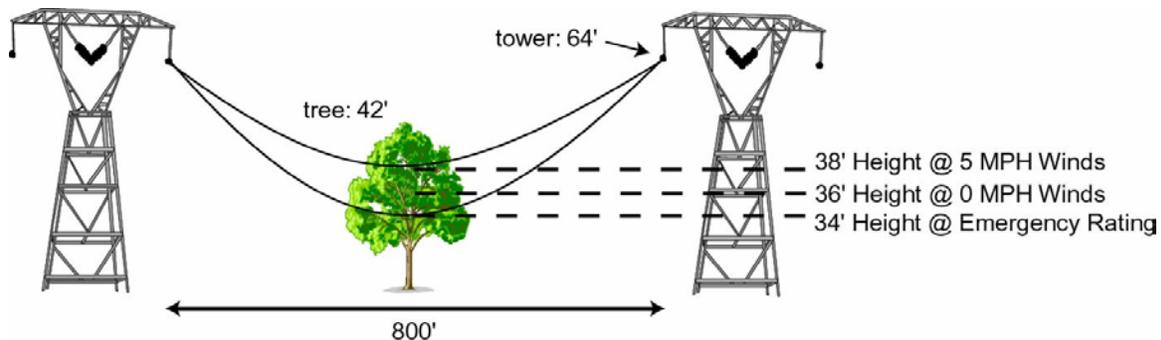
The presence of wind also influences conductor sag. Wind provides a cooling effect on the conductors. This cooling of the conductors reduces the amount of sag that would be encountered in comparison to sag on a calm day.

The following graphic provides an example of how conductor height can vary depending on load and wind velocity.

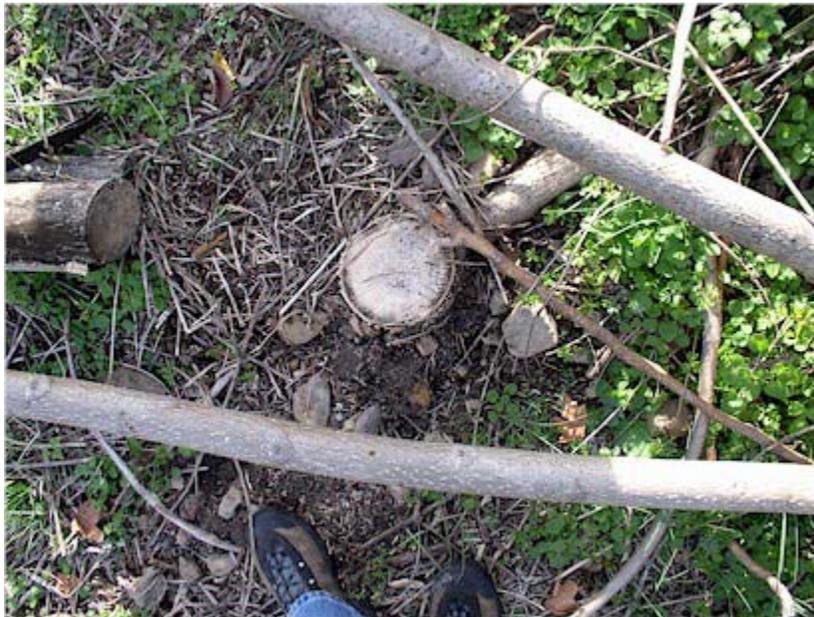
Trees and brush were felled on or after August 14th. Debris was left on site and inspected.

Two ailanthus trees showed evidence of significant fault current damage and were de-barked. One measured 2.5" diameter at ground line, and the other measured 6" diameter at ground line..

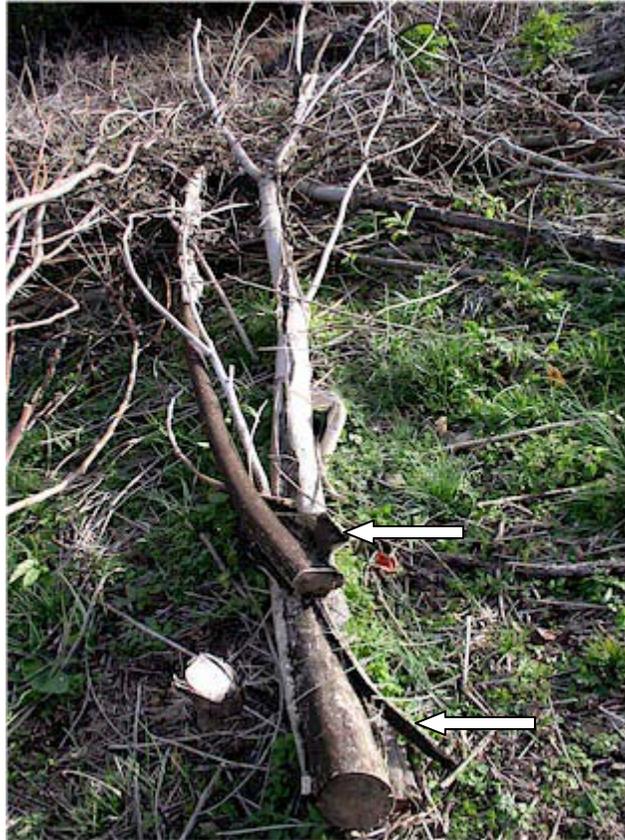
Both trees were estimated to be 30 to 35 feet tall. Other trees in the area showed evidence of fault current damage as well.

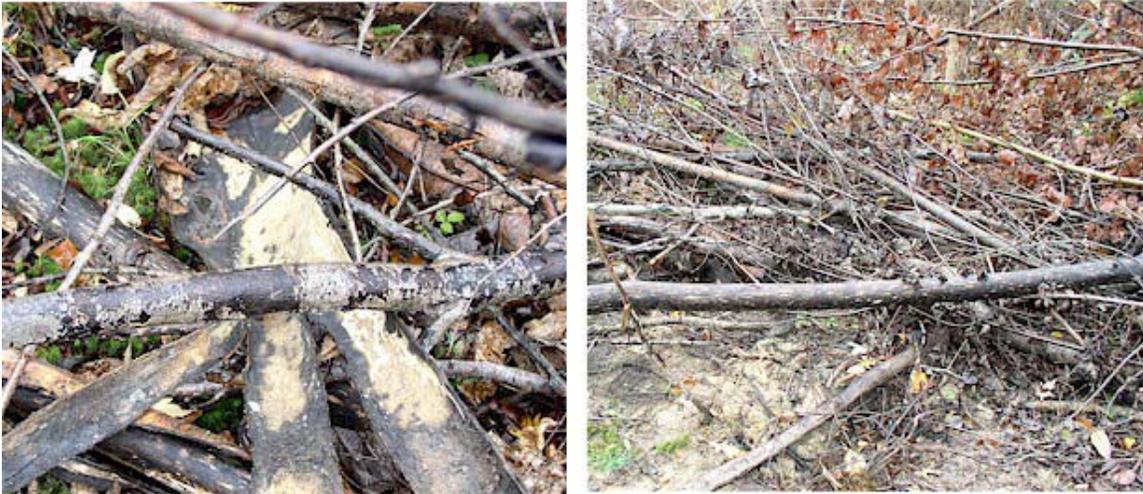
Inspected tree conditions at structure 40376 (20.5%) between towers 40375 and 40376. Trees and vegetation were felled on or after August 14th. Debris and tree parts were inspected on site.

Conductor height measured 44' 9". Tree height measured at 30 feet, although we could not verify location of the stump, or missing section of tree. Obvious significant fault damage to clustered trees. Charred limbs, and de-barked by fault current.

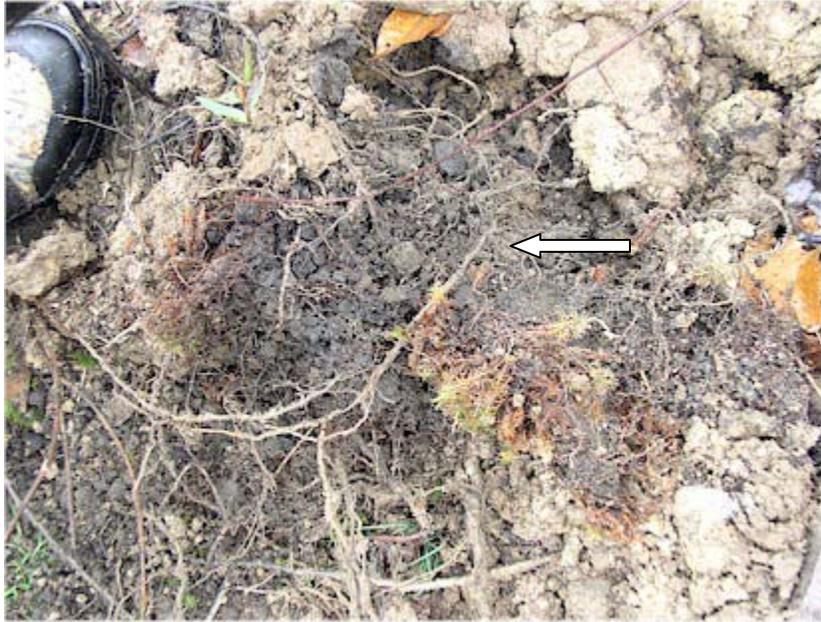
Topsoil in the area of trunk was disturbed, discolored and broken up at site. This is indicative of a higher magnitude fault or multiple faults.

Fourteen year-old tree in the middle of the right-of-way was recently removed.

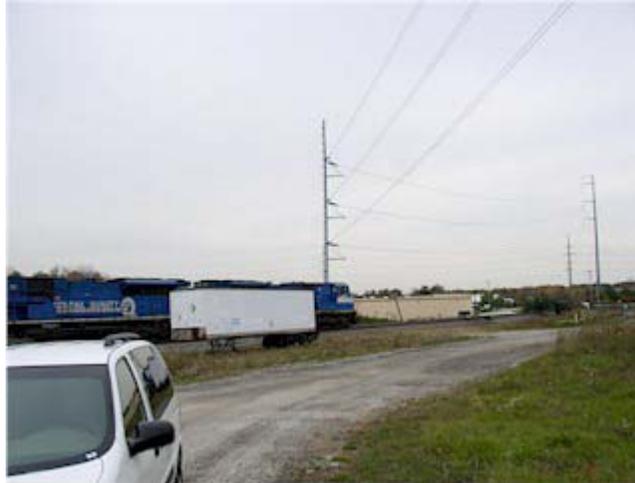
Calculated Fault Location: 11.3% from Chamberlin Substation, Tower 42852

No evidence of vegetation at calculated fault location (11.3%). See photo below.

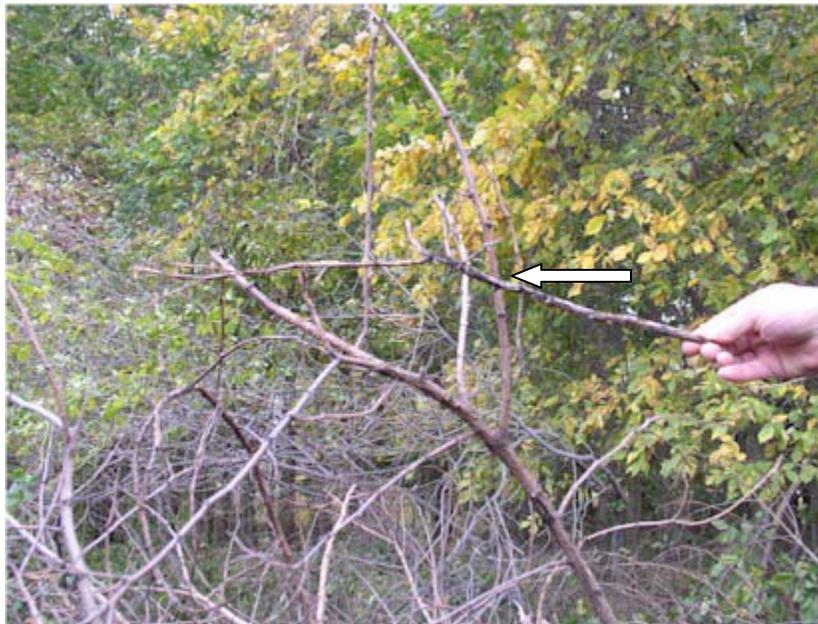
At 17.7%, between towers 42861 and 42860 we inspected vegetation. Trees and brush were felled on or after August 14th. Conductor height measured at 46' 7", tree height measured at 42'. Locust tree showed evidence of fault current damage. Tree damage indicated a lower level of fault current.

Burn marks were observed at 35' 8" up tree. Portions of the tree had been removed from the site making it difficult to determine exact height of contact, implying that the measured height is a minimum, and likely 3-4 feet higher than verifiable.

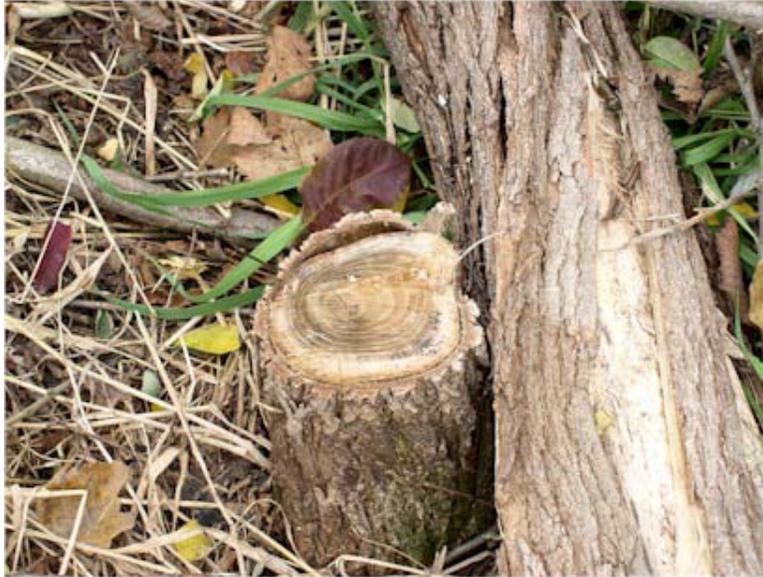
Other vegetation along the right-of-way measured between two and five inches in diameter at ground line. The following photo depicts a tree located in the right-of-way that was over six years old, as indicated by the growth rings.

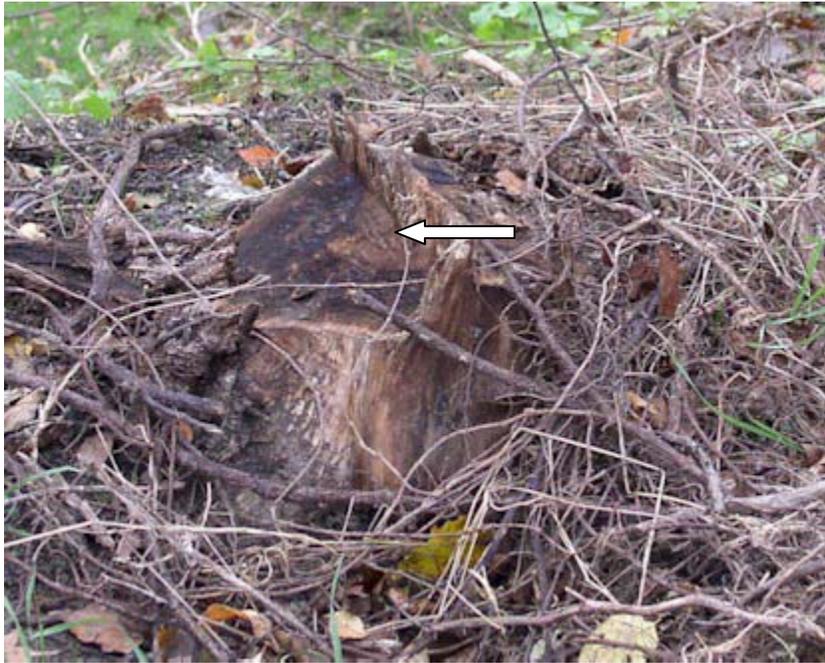
Conductor height measured 48' 9" at fault location. No evidence of tree debris at site. Walnut tree stump measured 14" diameter at ground line.

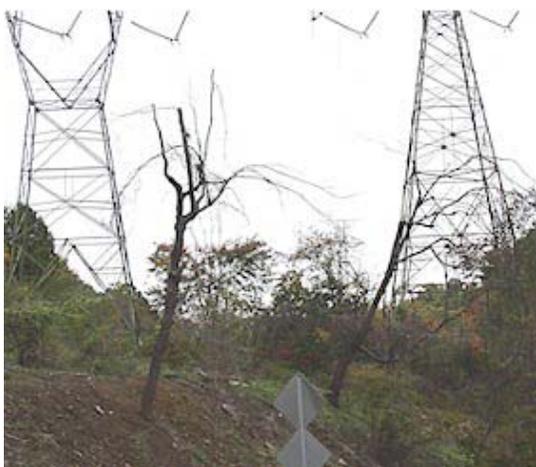
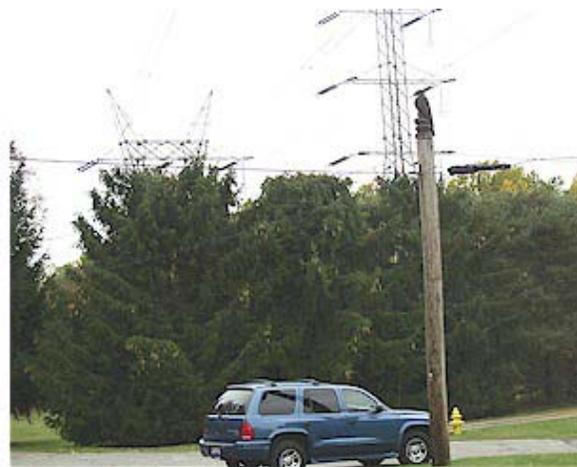
Subsequent clearing left trees and brush that, in our opinion, could have been removed as indicated by the photo below on the left. This photo was taken in the same span as the fault occurred. Other trees were pruned and left in the right-of-way as part of a landscaped area as indicated by the photo on the right. This photo was taken within one span of the fault.

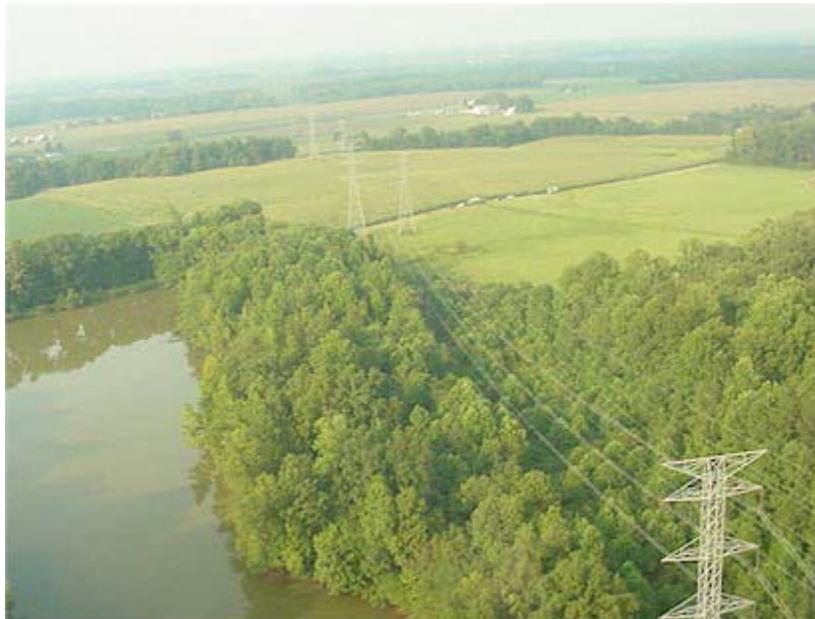
Based on discussions with Cinergy, this transmission line fault occurred as a result of tree contact in one span of the Columbus – Bedford circuit. The photo below was taken prior to August 14th.

Apparently work on this span had been halted various times by the owner of the property. The owner of the property had severely limited the ability to achieve necessary clearances and to apply herbicides to control future growth. While Cinergy does, in fact, have documented rights to perform this work (documented easement), this landowner has successfully halted work from proceeding on several occasions. This included the homeowner obtaining a court-granted temporary injunction halting work by Cinergy. Note: the required work was finally completed on October 9, 2003 as depicted in the photo below.

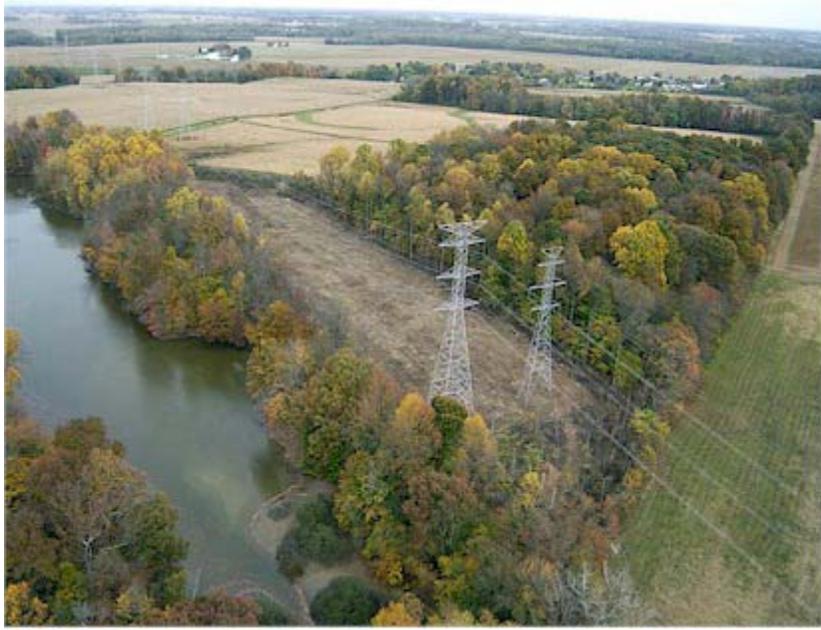
We bring this up to illustrate that there are many hurdles every utility company must face when trying to maintain lines clear of vegetation. In this particular case, it was a landowner that halted work. In other cases we are aware of, it can be local, state, or even federal agencies that hinder progress. See Appendix 'D' for a detailed description of this incident.

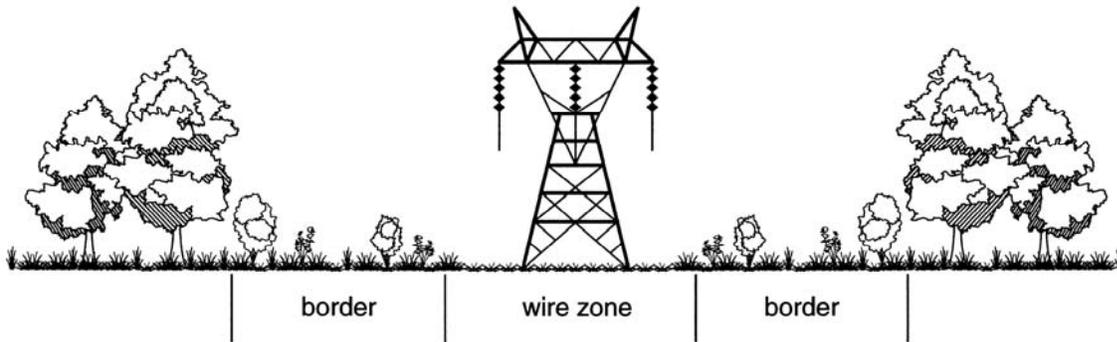
Bramble and Byrnes Wire Zone – Border Zone (From Yahner, Bramble and Byrnes, 2000)

Discussion: As previously mentioned, utilities should work toward the achievement of “Wire Zone – Border Zone” objectives on new and existing ROWs. This involves shifting plant communities found on the current ROW away from predominately tall-growing plant species in favor of plant communities dominated by naturally low-growth plant species. This shift is accomplished by selectively controlling tall-growing plant species, while preserving and encouraging low-growing trees, woody shrubs, grasses, herbs, and forbs. The establishment of this new cover type typically occurs after successive cycles of work and requires a long-term commitment from the utility. In determining the site-specific requirements to achieve the Wire Zone, Border Zone ideal, a variety of vegetation management techniques is considered. These may include biological, chemical, cultural, manual, or mechanical techniques. The choice of the best technique(s) is based on effectiveness, environmental impact, site characteristics, worker and public health and safety concerns, and economics.
